R&D Fund Project

Study Of GE 1st Stage Nozzle Premature Failure And Enhancement Of Refurbishment Procedures

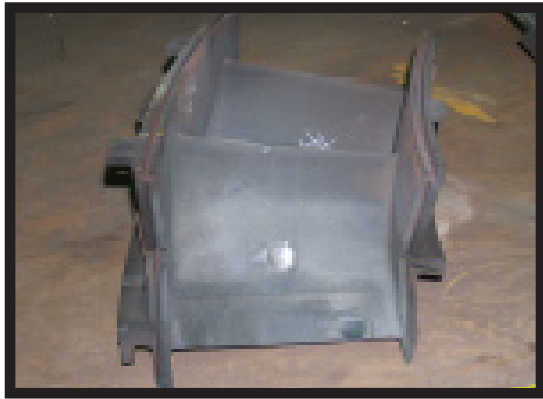
First stage nozzle premature failure

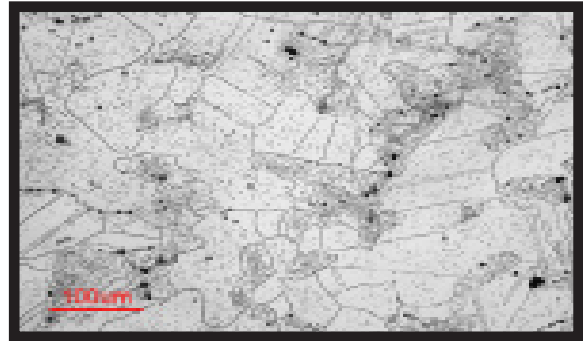
Creep cavities
