R&D Fund Project

Study On Gas Turbine Exhaust Stack Cracking Failure At Putrajaya Power Station

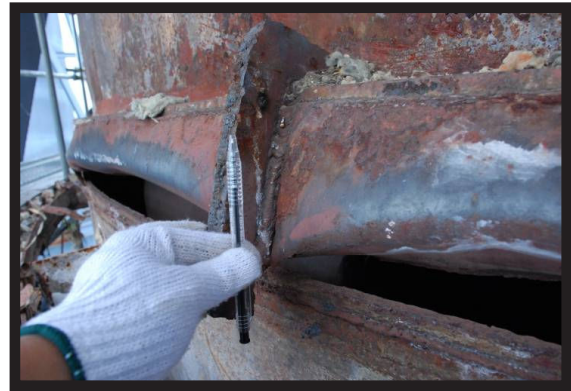
Crack Opening at Ring #3

In August 2007, Unit 5 Siemens' gas turbine chimney system at Putrajaya Power Station experienced cracking at its exhaust gas stack, which is approximately 15 meters in height. The cracks' features are circumferential with maximum crack opening of 125mm. Since the cracks may pose possible danger to the structure integrity, temporary repair work was carried out by the station during a short outage. TNB Research was requested to solve the problem and to come out with solutions to prevent the cracking from recurring in the future.

Based on the recommendation given by TNBR, the station will conduct visual inspections on the exhaust gas stacks in January 2010. The objectives of these inspections are to find out whether the old cracks have propagated and to find out any signs of new cracks.
