R&D Fund Project

Root Cause Analysis Of Trench Capacitor Voltage Transformer Failure

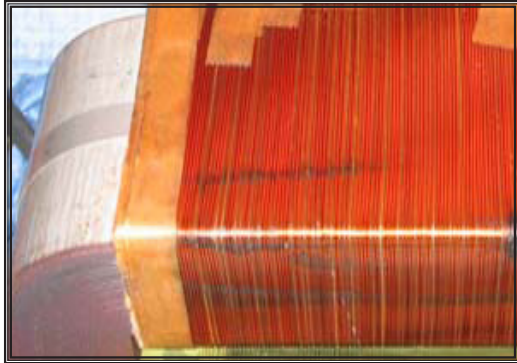
Punctured hole in 275kV series reactor

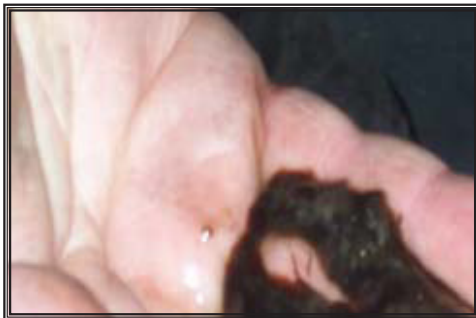
Sludge found in 132kV CVT Basebox
